Simple Overhead Repairs with Belzona® 4141

Concrete support columns for electricity supply cables at local sub-station.

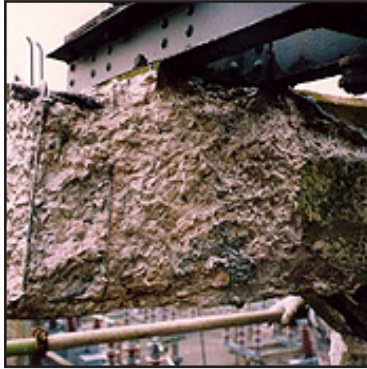
Close up of the badly spalled concrete

Severe spalling of the concrete accelerated by the acidic atmosphere generated by local industries.

Application was carried out using similar techniques to those detailed in Belzona® Know-How leaflet RPA-2. Repairs were finally overcoated with Belzona® 5151 as preventive maintenance on surrounding concrete surfaces.

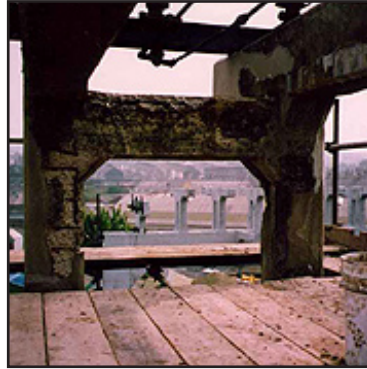
Work carried out from simple scaffold platform

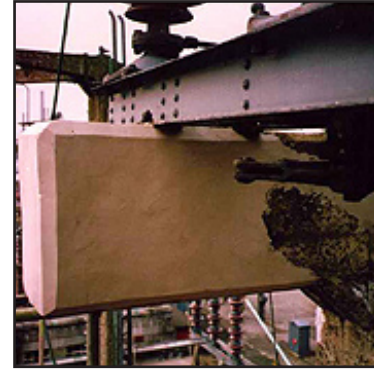
Close-up of a rebuilt beam prior to application of Belzona® 5151

Use of Belzona® 4141 allowed rebuilding to be carried out without the need to construct special shuttering and use of Belzona® 5151 will ensure similar problems on surrounding areas will not occur.
