Belzona Solves Chronic Expansion Joint Problem

San Antonio Airport,
Texas, USA

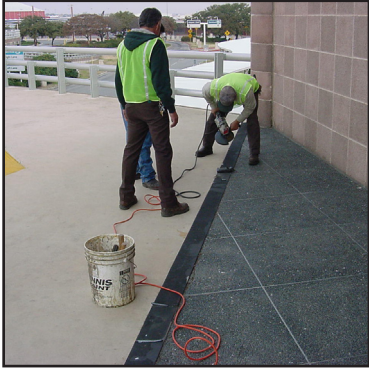
Joint before - showing old system

Previous repairs included steel covers over the joint. Then non-skid tape was added. Plates vibrated loose and along with the tape became trip hazard.

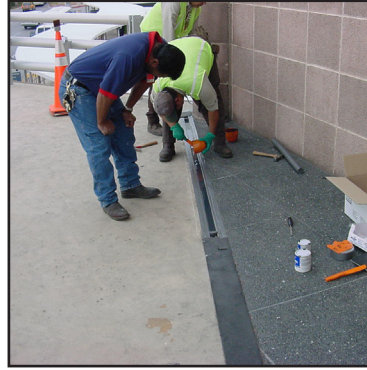
Belzona® 2221 being poured into joint

Application was carried out in accordance with Belzona system leaflet FPA-6 & FPA-8. Joint sealed with Belzona® 2221 system and Belzona® 4411 applied on both sides to provide neat, safe surface.

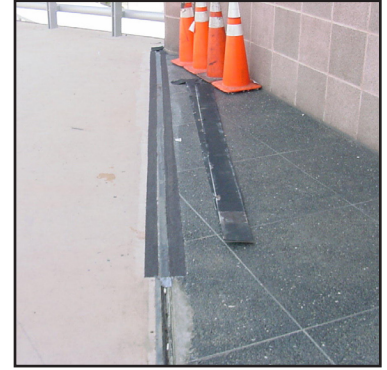
Finished joint with Belzona® 2221 and Belzona® 4411
(Note: old steel covers and tape)

Client needed a durable, watertight, non-slip solution to this nagging problem. After three years of service, joints holding up well.
