Belzona Keeps This Passenger Ferry Running Smoothly

Rudder horn of large ferry vessel.

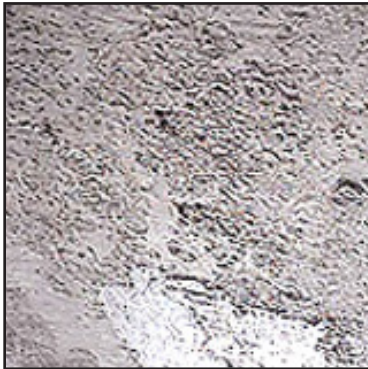
Cavitation clearly evident

The sides and trailing surfaces of this large rudder horn suffered from cavitation and significant metal loss.

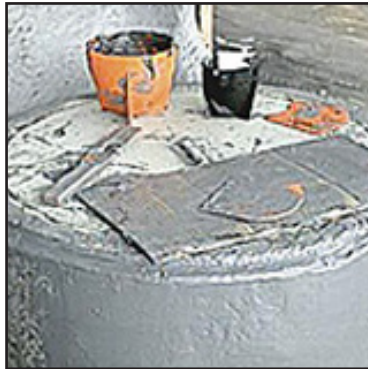
Rebuilding with Belzona® 1121 (Super XL-Metal)

The application was carried out in accordance with Belzona Know-How System Leaflets SOS-1 and -2.
