## Belzona Saves Retirement Residence Over \$7,000

Rooftop exhaust fan shroud.

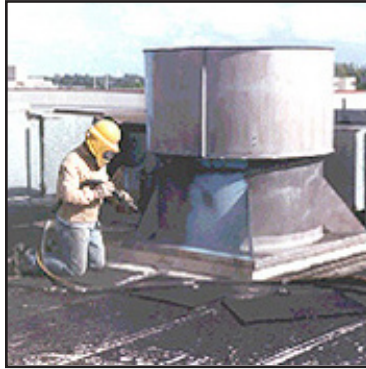
*Shroud grit blasted*

A six foot diameter exhaust fan is used in case of a fire to evacuate smoke from the burning building. The corroded metal shroud developed holes. Rainwater entered through the holes and caused water damage to the inside of the building.

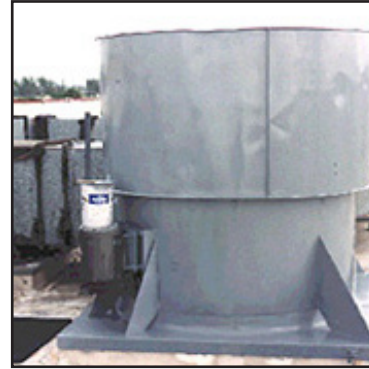
*Completed coating with  
Belzona® 5111 (Ceramic Cladding)*

The application was carried out in accordance with a Belzona Know-How System Leaflets FBC-2 and -4.

The cost of a new stainless steel shroud was \$9600. The existing shroud was salvaged with approximately \$600 in products. Including blasting, the customer saved over \$7000.
