Belzona Capitalizes on Coalescer

Oil/Gas Producer,
Venezuela

Electrostatic Coalescer.

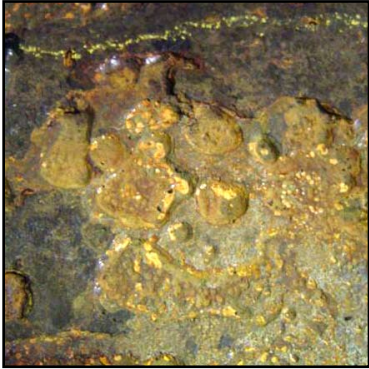
Extent of the corrosion due to the effects of the microbiological attack.

Microbiologically-induced corrosion (MIC) had severely affected portions of this vessel.

As the damage to the vessel was well defined, only the bottom portion of the vessel was treated. Careful surface preparation was implemented as the microbiological impact over the metal was extensive. Detection tests to confirm microorganisms made it a necessity to carefully clean and prepare the metal surface. Ultimately, the Belzona® 1121 was used to rebuild the corroded areas, followed by Belzona® 5891 as the coating material.

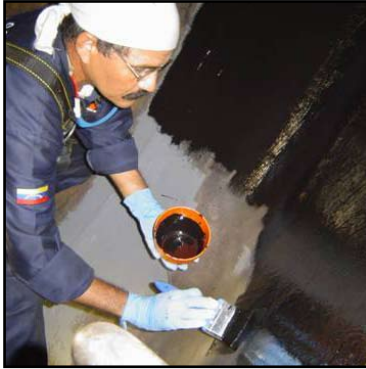
View of the application underway. Belzona® 1121 and Belzona® 5891 were used.

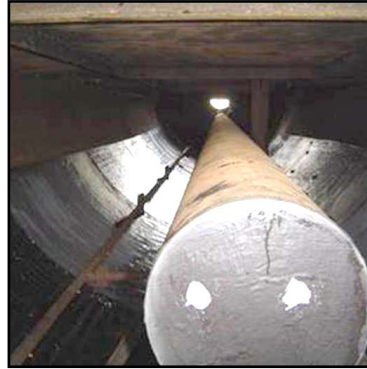
Final view of the entire bottom portion of the vessel that was treated.
