## Belzona Rebuilds Bearing Surface on Paper Machine Drive

Bearing fit on paper machine drive

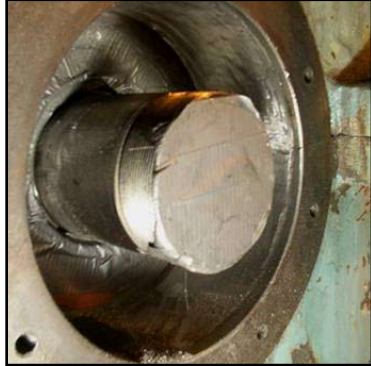
*The bearing fit area ground to provide a rough surface and degreased with Belzona 9111*

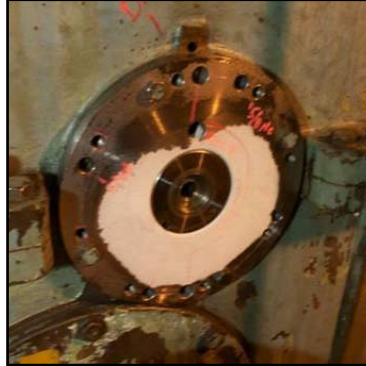
*The mold was positioned carefully before injecting Belzona 1321*
