Belzona Seals Insulator Leaks

Power Plant,
British Columbia, Canada

Power Line Insulators

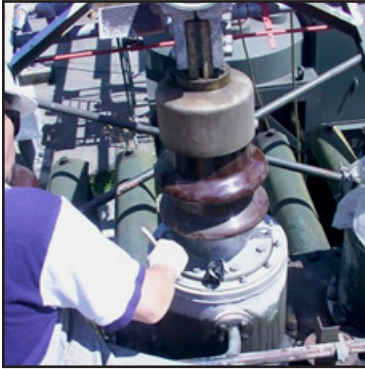
Surface preparation in progress

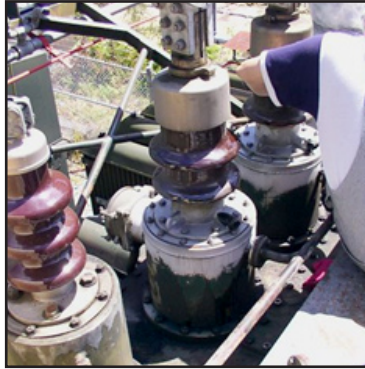
Surface preparation by grit blasting completed

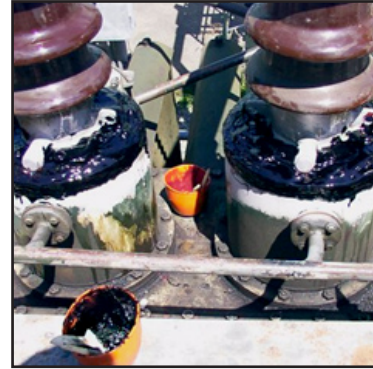
Completed application
