Belzona Repair of Access Ramp and Steps

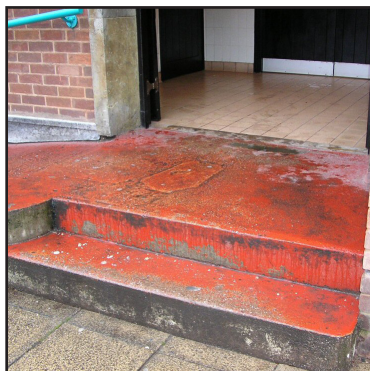
Worn steps were a health and safety hazard

Much foot traffic and heavy weathering caused the steps and disabled access ramp of these public toilets to become damaged and worn. An inspection of the ramps according to the Disability Discrimination Act (DDA) found them to be unsafe and not compliant.

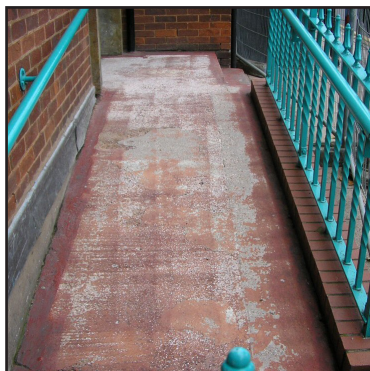
Prepared surface

Application was carried out in accordance with Belzona Know-How System Leaflet FPA-1.

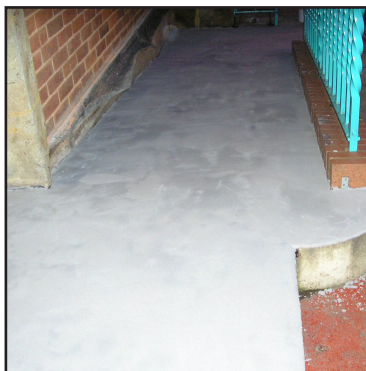
Surface rebuilt with Belzona® 4131

The use of Belzona® products was requested by the council in order to give a fast, long life, cost effective repair. The ability to bond and build up old concrete meant that the steps did not have to be completely removed and rebuilt. This ensured that the toilets would comply to the DDA standards. These heavily used toilets were quickly reopened to the public.

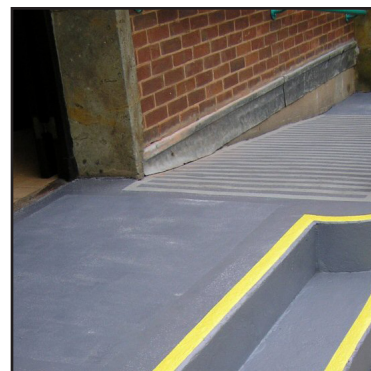
Completed project
