Belzona Becomes Standard Repair on Bottle Filling Equipment

Cast iron bottling table for soft drinks

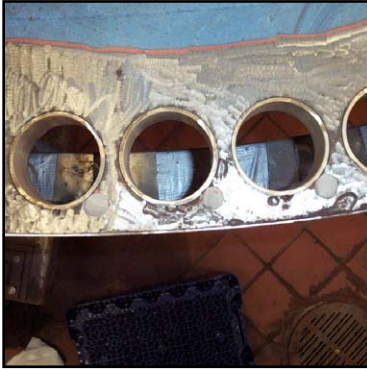
Bushings installed and table prepared. Note deep corrosion pitting

Tooling pockets are rebored and bushings installed. Where the pockets are corroded excessively and bushings can't be shrunk fit they are installed in Belzona® 4301 as per Belzona Know-How System Leaflet ENC-3b. The surface is then repaired with Belzona® 4301 and coated with Belzona® 4311 as per System leaflets TCC-3 & -5. Stainless plates are installed and seated in the wet Belzona® 4311 for permanent protection from future spillage.

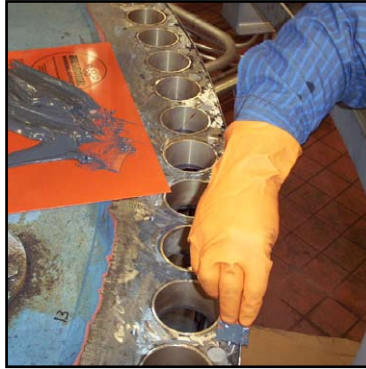
Surface restoration with Belzona® 4301

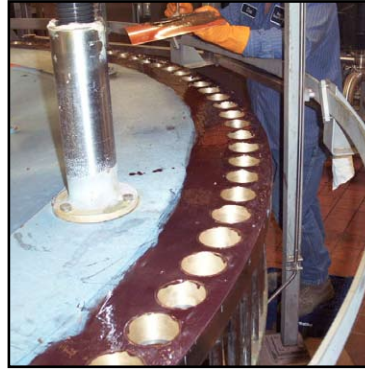
Surface coated with Belzona® 4311

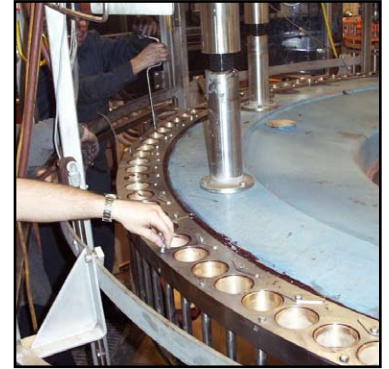
Stainless steel plates seated in Belzona for full support and corrosion protection
