Belzona Repairs to Rooftop Exhaust Ducting

Rooftop exhaust ductwork

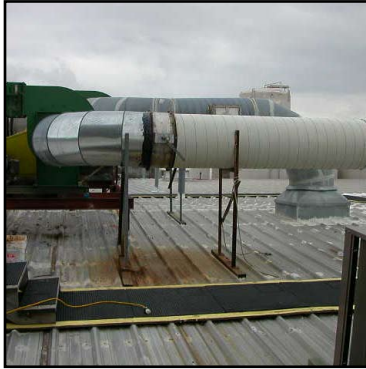
First duct joint

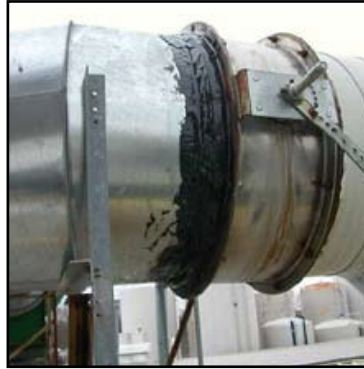
Close up of first joint repair

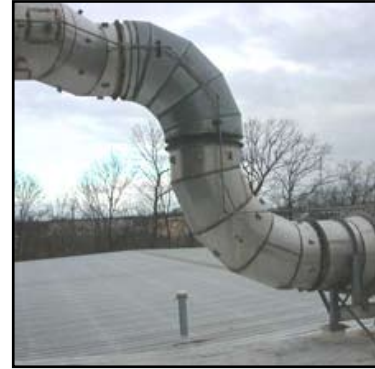
Second joint repair
