Belzona Repairs and Improves Francis Turbine Runner

Francis Turbine Runner.

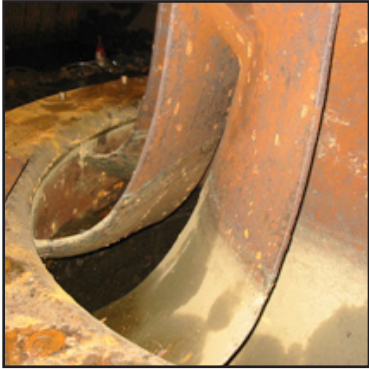
Damaged and worn runner

The runner had suffered extensive damage from erosion, corrosion and mechanical damage.

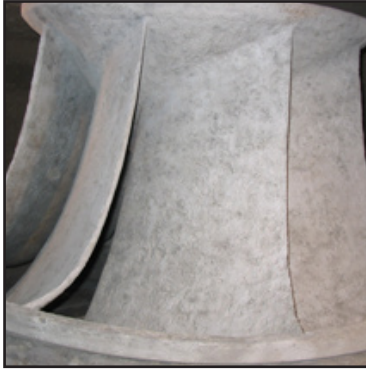
After grit blasting

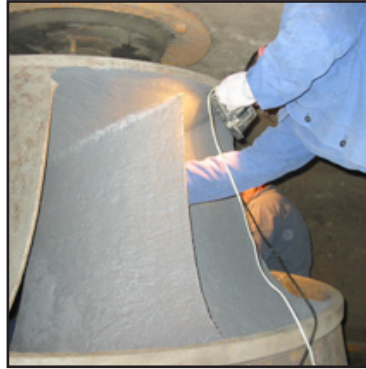
Rebuilding with Belzona® 1111

The application was carried out in accordance with Belzona® Know-How System Leaflets CEP-8 & -10.

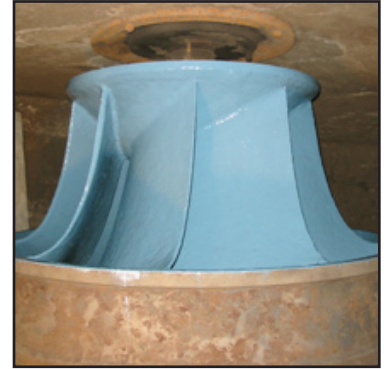
After coating with Belzona® 1341

After one year operation the runner was inspected and was found to have only suffered minor damage due to impact with pieces of wood. After the repair and coating of both the runner and wicket gates a 10 - 15% increase in output was recorded and the turbines were able to run at a greater range of heads than were possible before, thus earning the customer many times more in profit than the cost of the repair.
