Classic Pump Refurbishment with Belzona

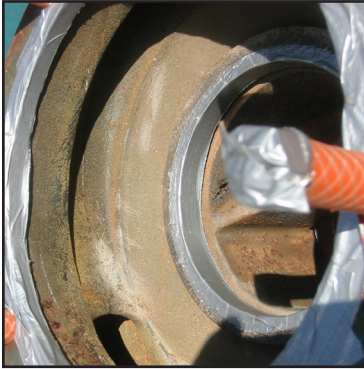
Rebuilding profiles underway

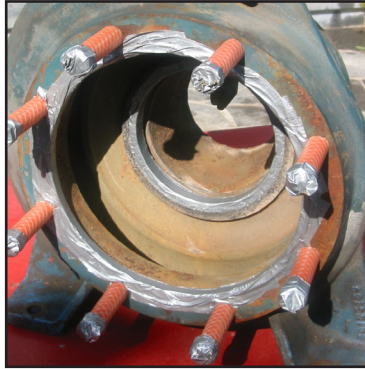
Another view of profiles

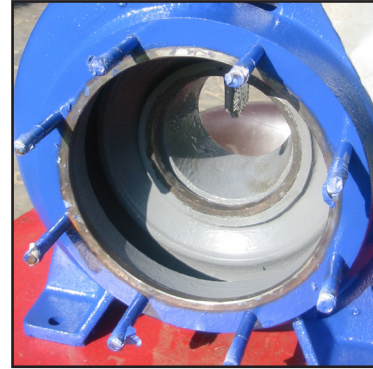
Completed application
