Belzona Protects Mixing Tank

Dairy,
Oklahoma, USA

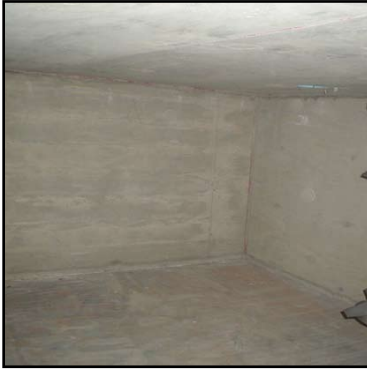
Bare unprotected mixing tank

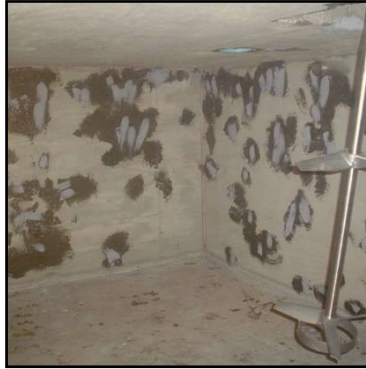
Surface prepared and holes patched with Belzona® 4111

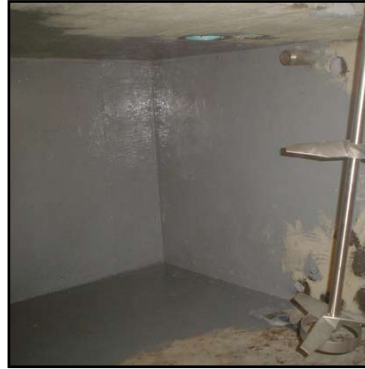
First coat of Belzona® 5811 being applied

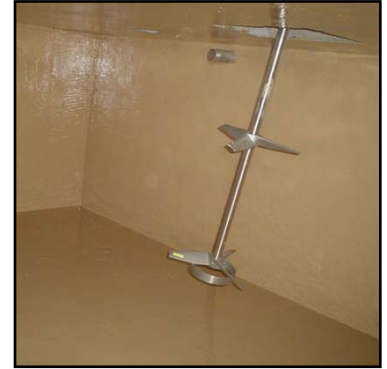
Final coat Belzona® 5811 applied
