Typical Chiller Repair With Belzona

Chiller unit from the hotels air conditioning plant.

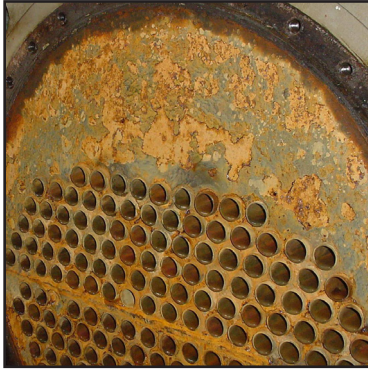
The corroded tube sheet

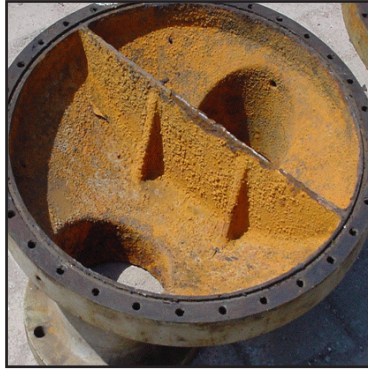
Rebuilding the division bars

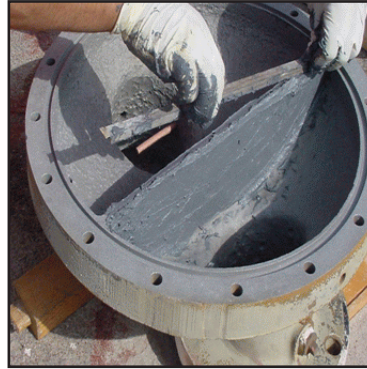
End cover being coated

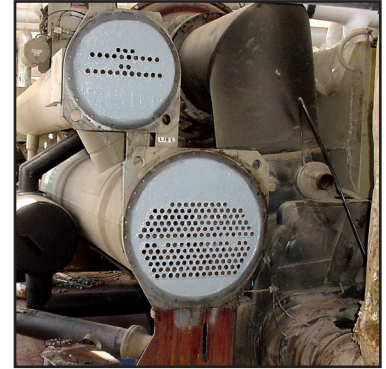
Tube sheets were protected by Belzona® 1321
