Large Hole in Tank Repaired with Belzona

Coal fired Power Plant
Missouri, USA

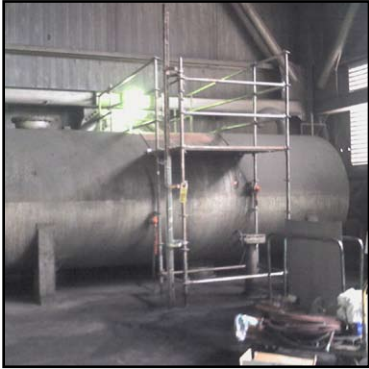
General view of the tank

The tank developed a large hole in the top due to years of corrosion.

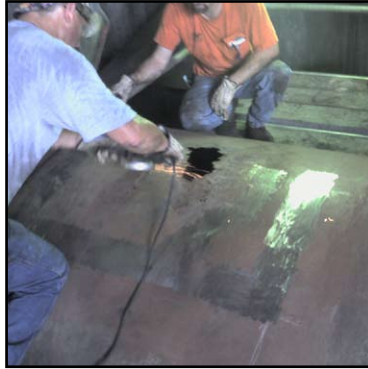
Surface preparation underway

Tank was repaired in accordance with Belzona Know-How System Leaflet TCC-1.
Doubler plate was bonded over the holed area.

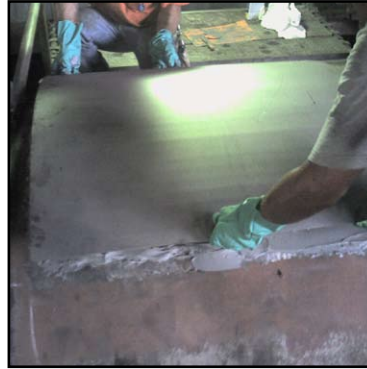
Doubler plate being positioned and bonded in place

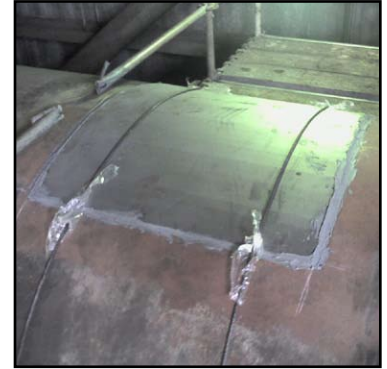
Completed repair
