## Belzona Seals Tailshaft Liner

240mm Tailshaft from a 2500 Tonne Deadweight Coastal Products Tanker, passing through aft peak tank.

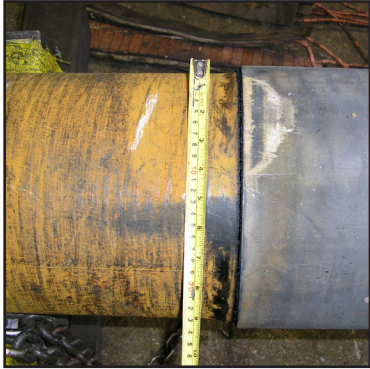
*New liner fitted to shaft*

The bronze liners had worn and required changing. The body of the tailshaft was coated with a vulcanized rubber lining which was generally intact. Following changing of the Bronze liner the Rubber lining was damaged and not sealing. This could have lead to crevice and bi-metallic corrosion.

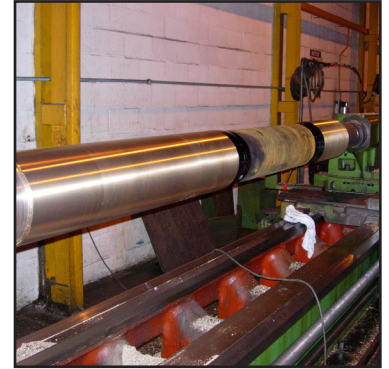
*Tailshaft complete - all works were undertaken on the lathe*
