Belzona Protects Fast Ferry Bow Thrusters From Cavitation

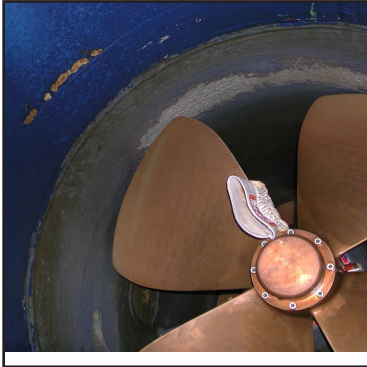
Localized damage to Belzona® 1341 (Port)

Cavitation problems had manifested themselves in the Port and Starboard Bow Thruster Tunnels. Annual repairs had been attempted with glass flake coatings and Belzona® 1341, but none had been ideal allowing metal loss to continue in the tunnel.

Following removal of the existing coatings Belzona® 2141 was applied in accordance with a modified version of SOS-1 & 2.

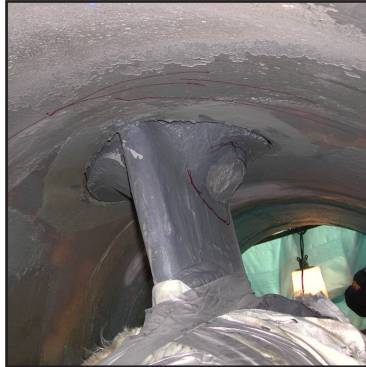
Extensive damage to Glass Flake lining (Starboard)

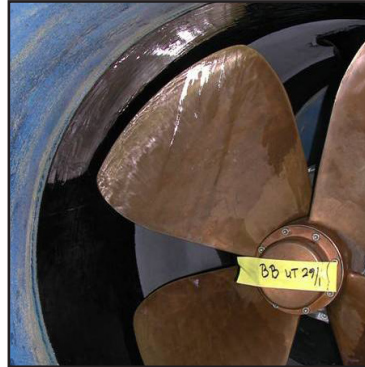
Belzona® 2141 (Portside)

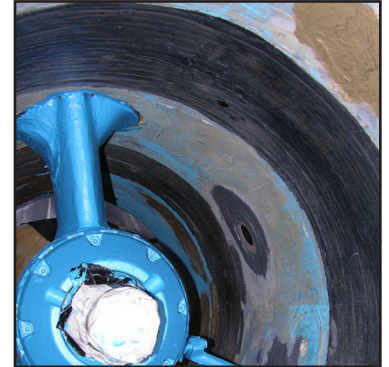
Inspection after 5 years service

Subsequent annual inspections, most recently in 2007, have shown the Belzona® 2141 to provide outstanding cavitation protection reducing the annual docking cycle from annual to bi-annual for the client. The client is intending to coat the other non-Belzona protected areas as a result.
