Belzona Seals Condenser Expansion Joint

The #4 generator condenser expansion joint.

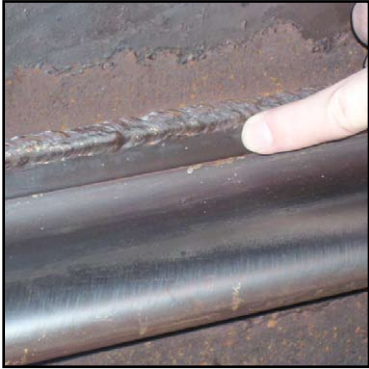
Leaking Expansion Joint

The efficiency of the unit was low because of the leaks in the expansion joint.

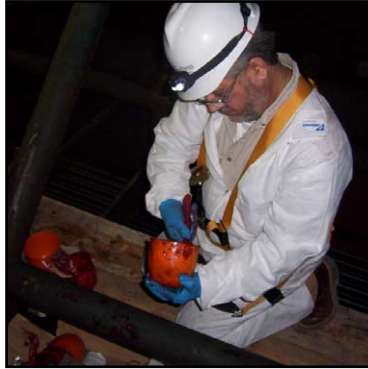
Mixing Elastomer

Application was carried out in accordance with Belzona Know-How System Leaflet HEX-5. The surface was prepared with a vacublast unit. After Conditioning, three coats of Elastomer were applied to the expansion joint and approximately one inch beyond the joint.

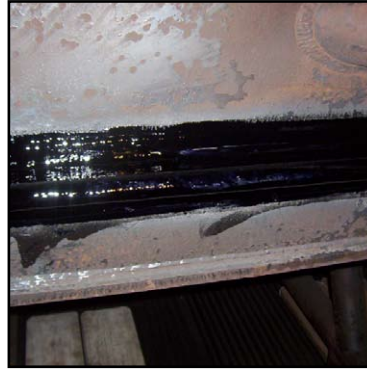
First coat
