Belzona Extends Chiller Life

Museum,
Kansas, USA

February 2007

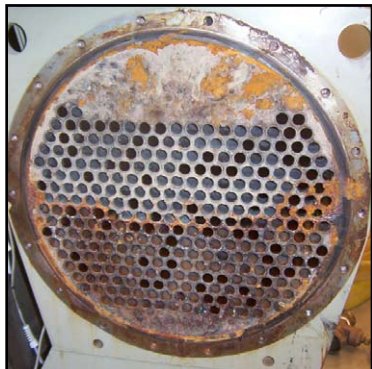
Tube sheet before blast cleaning.
