Acid Containment Floor Rehab with Belzona

Water Treat Plant,
Oklahoma, USA

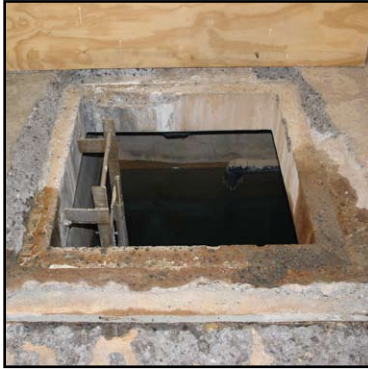
Floor prepared for resurfacing

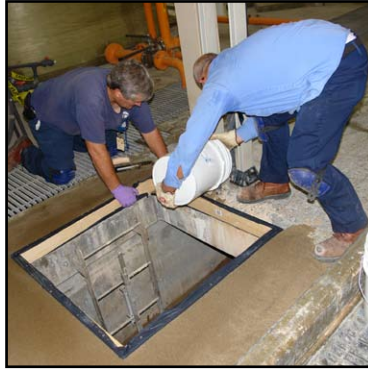
Reshaping the access opening

Application was carried out in accordance with Belzona Know-How System Leaflets FPA-1 & 3. Bulkfill was used to rebuild the sump access and spalled areas. The entire area was then given two coats of Immersion Grade with Surefoot Aggregate applied to achieve safe footing.

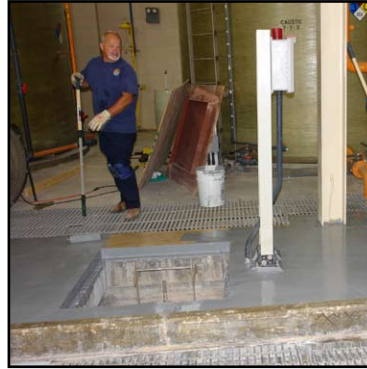
Belzona® 5811 Grey coat over Beige with Surefoot added

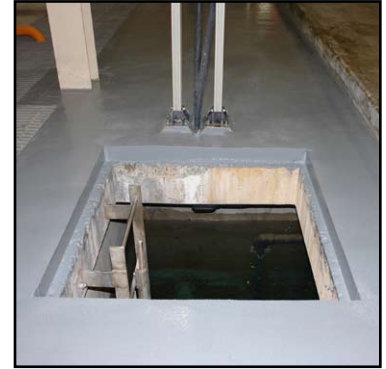
Rebuilt, protected, a 1st class job
