## Belzona Saves Rotor and Maintain Production

Rotor of Water Ring Vacuum Pump.

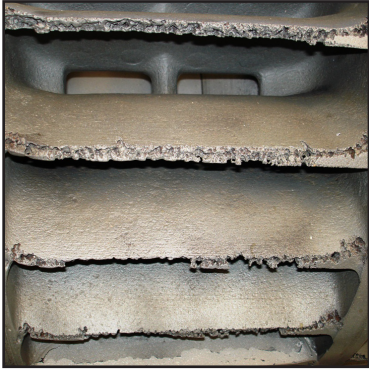
Main body of rotor severely eroded

Severely eroded, no replacement available. New Rotor would cost 11,000 USD.

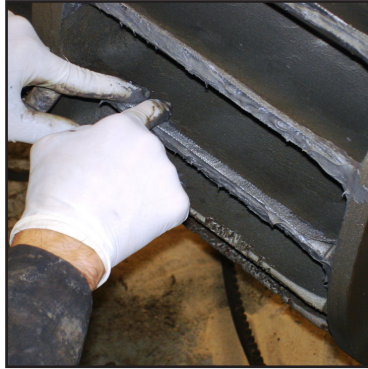
Rebuilding and reinforcing with Belzona® 1111

The application was carried out using a combination of Belzona Know-How System Leaflets FBC-2 and FBC-15.

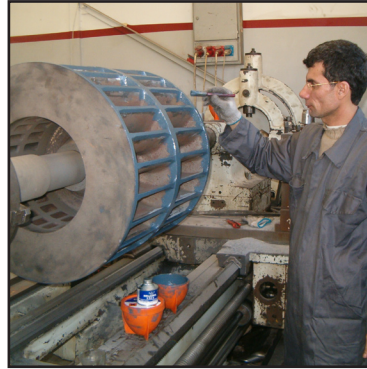
Top Coating with Belzona® 1321

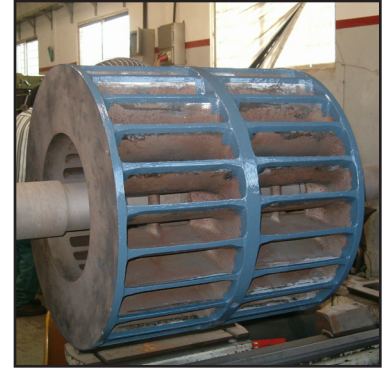
Ready to be in operation
