## Expansion Joint at Hospital Sealed with Belzona

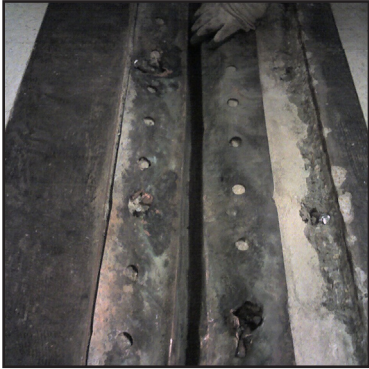
View of joint with kick plate removed

Expansion joints in the hospital had become a tripping hazard.

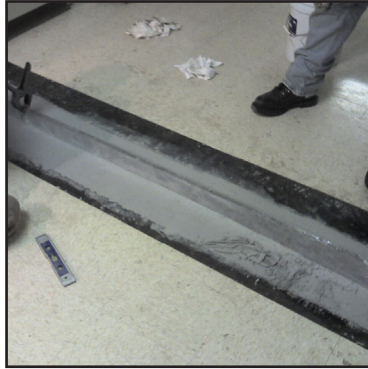
Application of Belzona® 4111

Application was carried out in accordance with Belzona Know-How System Leaflets FPA-5 and -6.

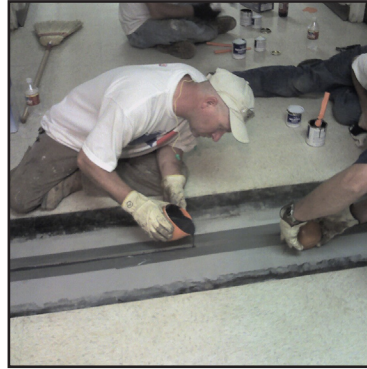
Application of Belzona® 2221

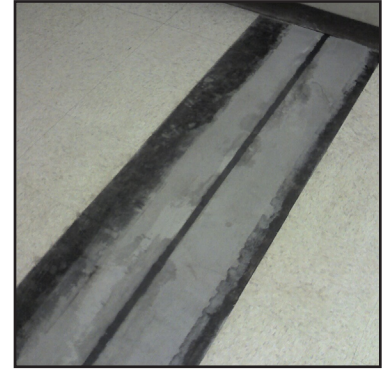
Completed application
