## Belzona Protects Drum Thickeners Against Corrosion

Wastewater Treatment Plant,  
UK

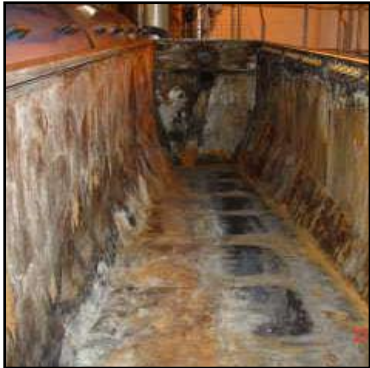
Original corroded condition

The mechanical drum thickener casings at this plant had corroded in service from contact with chlorides & sulfates present in the wastewater sludge being processed.

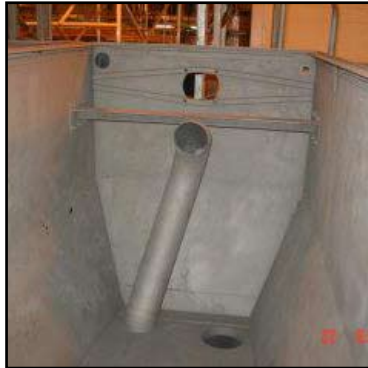
Blasted ready for repair and coating

After grit blasting the units any pitting corrosion was filled with Belzona® 1111 followed by fully lining with 2 coats of Belzona® 5811. Following the successful completion of this set of Drum Thickeners this company have since coated a second set using the same procedure.

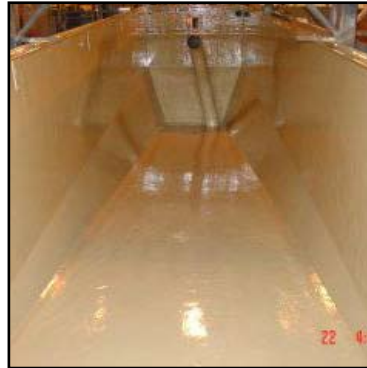
Belzona® 5811 first coat complete

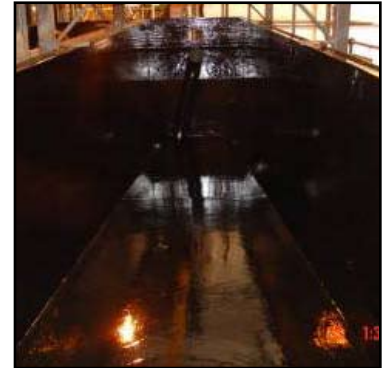
Completed application
