Belzona® 5851 Helps Avoid Shutdown

Production Rig,
North Sea

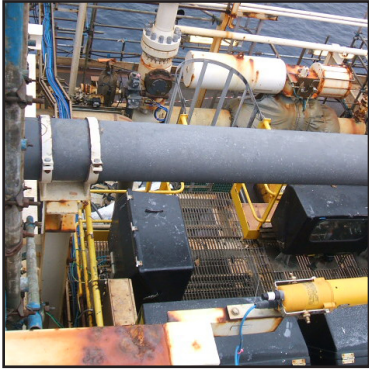
Manifold showing weathering of paintwork

Weathering of the original paint system on high temperature Duplex lines.

The loss of the original paint system exposed the pipe work to a risk of Stress Corrosion Cracking whenever the Fire protection Deluge system were tested.

Application carried out in accordance with modified Belzona System Leaflet VPF-2. The pipe-work was wet-blasted to remove poorly adhering paintwork and any salts from the substrate.

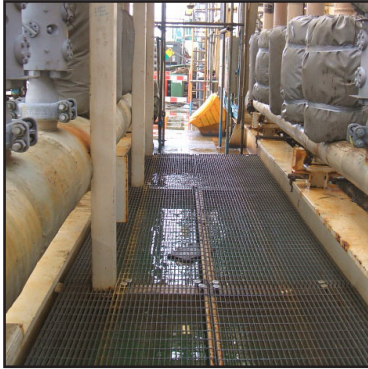
Belzona® 5851 applied to exposed pipe work

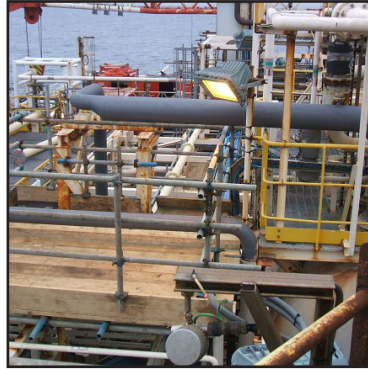
Belzona® 5851 applied to exposed pipe work

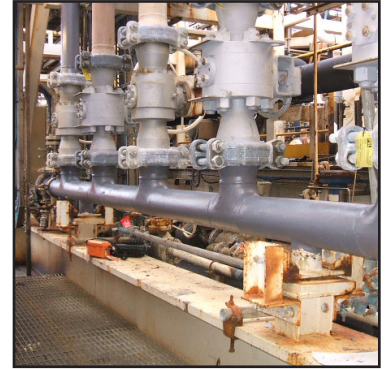
Belzona® 5851 applied to the Manifold
