Belzona Saves Refinery \$50,000

Refinery-Sweeny,
Texas USA

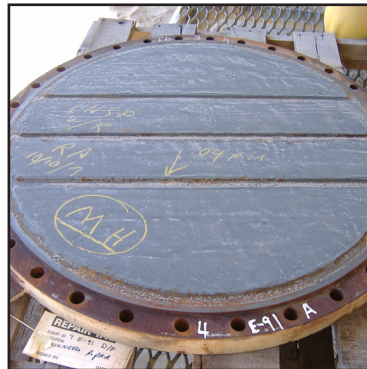
Heat exchanger after five years in service

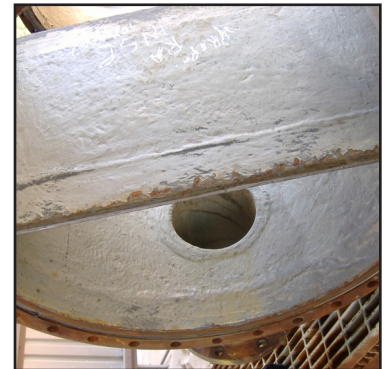
Heat exchanger channel head after five years in service
