Belzona Protects Clarifier

STATISTICS

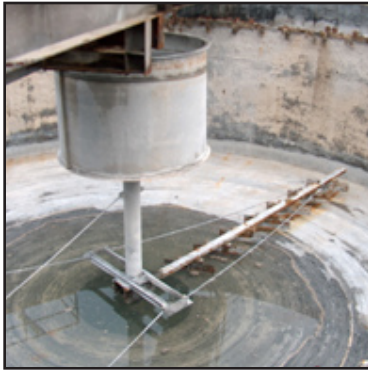
Before Belzona

Concrete damaged by erosion and abrasion led to underground leakages with contaminated water.

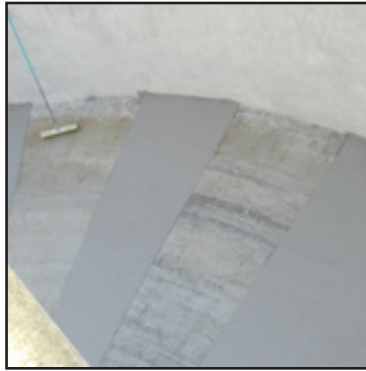
Application of Belzona® 4111

Application to wall carried out in accordance with Belzona System Leaflet TCC-5 using 100L Belzona® 5811. Tank floor screeded with Belzona® 4111 (1650Kg) in accordance with Belzona Know-How System Leaflet FPA-1.

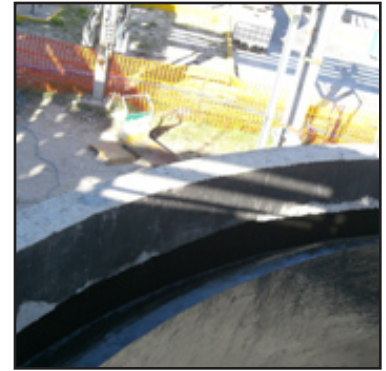
Completed application

Concrete was not a solution for the reconstruction of heavily damaged areas. The Belzona solution provided waterproofing, corrosion protection and abrasion resistance required on the floor.
