Belzona Protects Tube Sheet and Tubes

Condenser tube sheets and tubes.

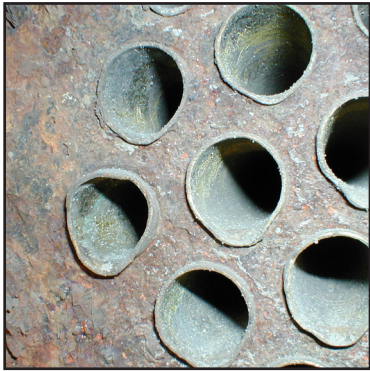
The corroded tube sheet

Corrosion problems were beginning on the tube sheet and inlet tubes (50 mm).

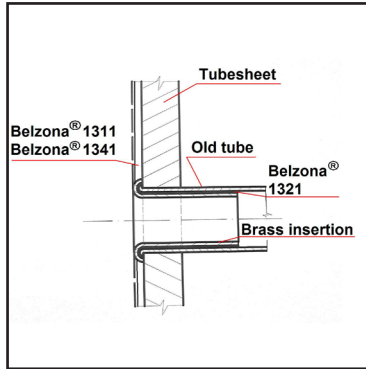
Sketch of the repairs

The application was carried out in accordance with Belzona Know-How System Leaflet HEX-1, HEX-2 & HEX-3.

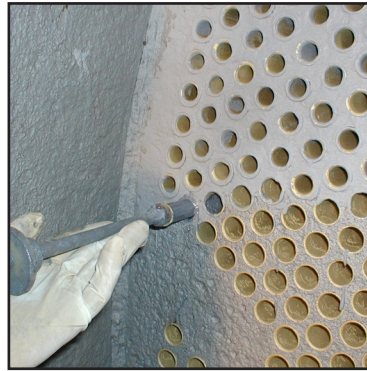
Loading insertions

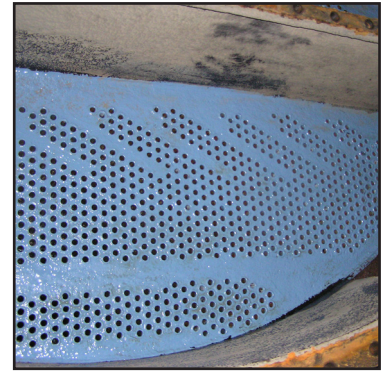
Application after 3 years
(still like new)

Belzona provided long term protection, increasing the life of the tube sheet and also inlet tubes, decreasing other repair and maintenance costs. Inspection after 3 years showed excellent protection being maintained.
