**Belzona Protects Waste Water Tank**

10,600 cubic metre waste water tank with inner surface of 3000m<sup>2</sup> containing waste water from pulp production.

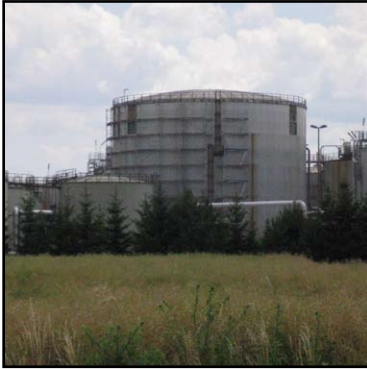
*10600 m<sup>3</sup> tank*

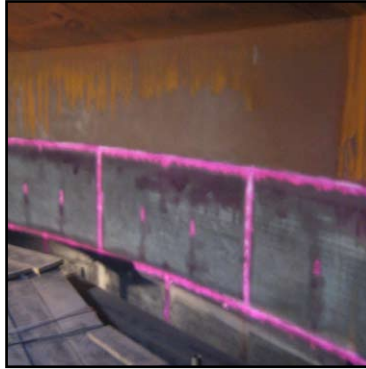
*Welded steel plates during crack testing*

Failed coating was removed by ultra-high pressure water jetting and grit blasting. Steel plates were welded in tank to guarantee mechanical integrity. Rebuilding of pitted steelwork carried out in accordance with Belzona Know-How System Leaflet TCC-5. Coating by heated airless spray in 2 layers.
