BELZONA® CLAMPS DOWN ON LEAKING PIPES

Oil refinery in the Netherlands

September , 2000

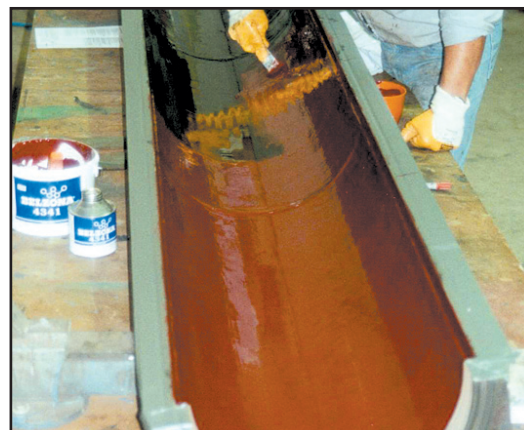
1. Clamps being coated with Belzona® 4341.
2. Clamps ready for service.

The application was carried out in accordance with Belzona Know-How System Leaflet TCC-5. Belzona® 4301 was used to smooth over the weld seams prior to the application.
