BELZONA® PROVES TO BE THE MATERIAL FOR CHEMICAL CONTAINMENT AREAS

Chemical refinery in Western North Carolina, USA.

Chemical containment area.

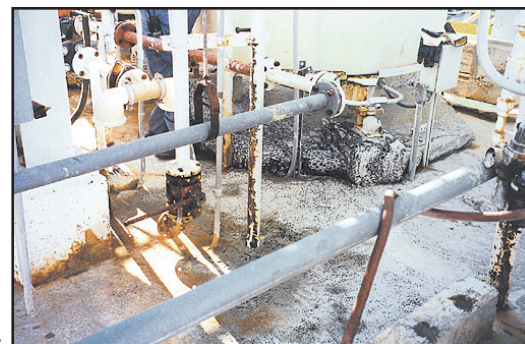
1. The area has been cleaned/degreased.
2. Belzona® 4131 is being used to rebuild the eroded areas.
3. Belzona® 4911 has been applied prior to the final coating.
4. The completed application.
