BELZONA® RECLAIMS AND PROTECTS SULFURIC ACID BUND

Sulfuric Acid Refinery - Wyoming U.S.A.

850 sq.ft. secondary containment area for 98% Sulfuric acid.

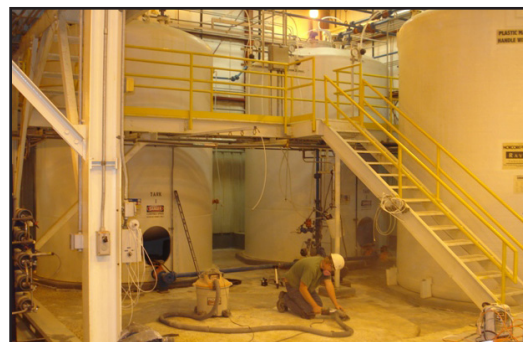
1. Overview of the acid containment area
2. View of the damaged concrete
3. View of area rebuilt and resurfaced
4. Completed job after coating with Belzona® 4311

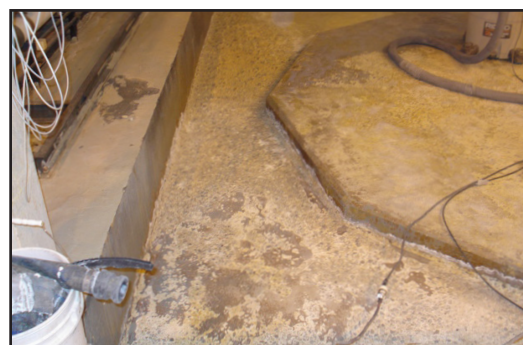
2.

Previous product used gave limited results. Extensive rebuilding of the concrete was needed to allow the containment area to drain to the center sump, to be followed by a protective coating.

Application was carried out in accordance with Belzona Know-How System Leaflet TCC-9 & 15. Concrete was rebuilt to create falls to central sump. All area was then protected with Belzona® 4311.
