BELZONA® SEALS 20,000SQ. FT.CONTAINMENT AREA

Chemical Plant, North Alabama U.S.A.

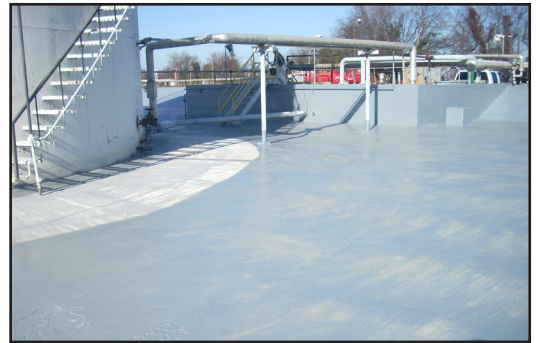
1. Over view of the containment area
2. Close up of the expansion joints
3. 2nd coat of Belzona® 5811 applied
4. Application completed with final coat of Belzona® 5111

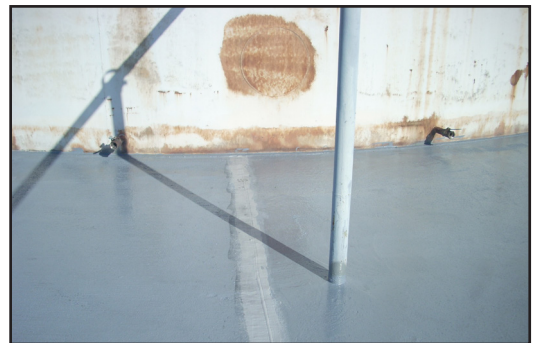
Cracks and failed coating over the concrete dyke.

Application was carried out using a modified Belzona Know-How System Leaflet TCC-15. The concrete was high Pressure Water Jetted to remove loose coating and expansion joint sealant. Joints then sealed with Belzona® 4521. 2 coats of Belzona® 5811 and a top coat of Belzona® 5111 for UV Protection applied to entire area.
