## BELZONA® PROTECTS CHEMICAL CONTAINMENT AREA

Food Processing plant, France

Chemical containment area

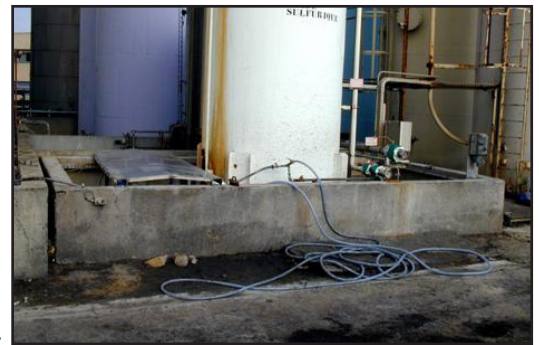
Heavy deterioration of the concrete due to leakage and contamination during maintenance operations. The integrity of the structure was compromised.

1. View before repairs
2. View of the tank supports
3. View after shimming
4. Application completed with Belzona® 4311 applied
