BELZONA® REPAIRS MEG TANK HOLED BY CUI

Oil Major St Fergus Gas plant, Scotland

May 2006

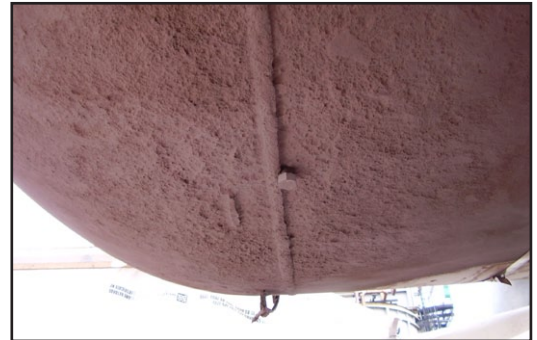
Corrosion Under Insulation (CUI) on the vessel had caused a pin hole in the vessel wall.

1. CUI with pinhole drilled, threaded and bolted
2. Application of Belzona® 1111
3. Completion of the Application of the Belzona® 1111 externally
4. Application of Belzona® 1111 & 1321 internally over the bolt
