BELZONA® GETS THE NOD WHEN DOWNTIME MUST BE MINIMIZED

Geothermal Plant in the Philippines

Anchor casing.

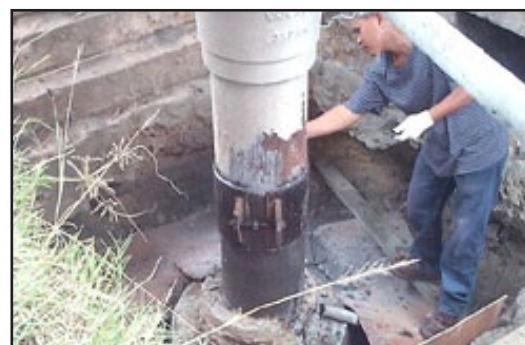
1. Pitted areas are rebuilt with Belzona® 1251 prior to Belzona® 5851 application.
2. Belzona® 1251 is heat cured in service with adhesion strength of 3200 psi.
3. Final coat of Belzona® 5851 for extra protection.

Manual surface preparation was used. Next, a new metal jacket was placed over the heavily pitted areas and bonded in place with Belzona® 1251. After the material began to cure, Belzona® 5851 was used to coat the entire area for extra protection.
