CORRODED PIPEWORK: A THING OF THE PAST WITH BELZONA® 5851

Oil refinery in New Zealand

Corroded pipework and columns.

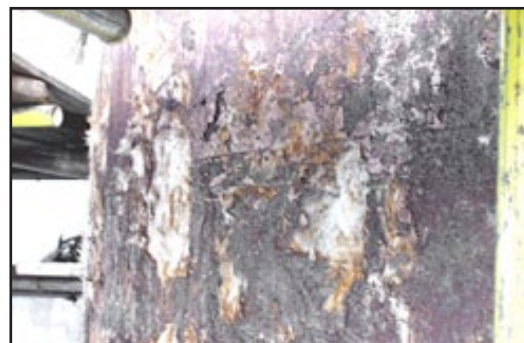
CUI (Corrosion Under Insulation) was causing costly shutdowns to under-take repairs.

1. Prior to application, corrosion can easily be seen.
2. Belzona® 5851 (HA-Barrier) is easily applied to hot surfaces by trower, brush, or even spray.
3. Belzona® 5851 (HA-Barrier) is easily applied to hot surfaces by trower, brush, or even spray.

Manual surface preparation was done with high pressure water blasting. Belzona® 5851 (HA-Barrier) was applied directly to hot pipework while in service.
