COATING TECHNOLOGY INCREASES PUMP PERFORMANCE

Jérémie Maillard

Belzona Polymerics Ltd, Claro Road, Harrogate, North Yorkshire HG1 4DS
Tel: +44 (0) 1423 567641 Fax: +44 (0) 1423 505967 email: jmaillard@belzona.com
www.belzona.com

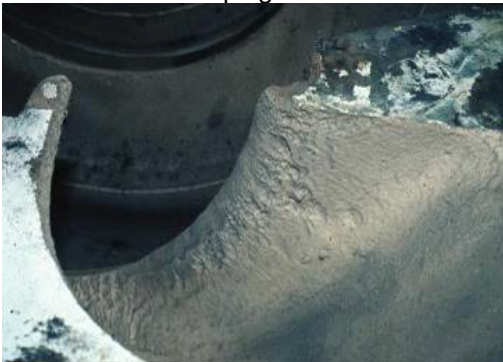
Fig 1 – impingement erosion

Impingement is caused solely by high velocity fluid flow, and its effect on the substrate, such as in this example where high fluid velocities are occurring due to high pressure to low pressure leakage.

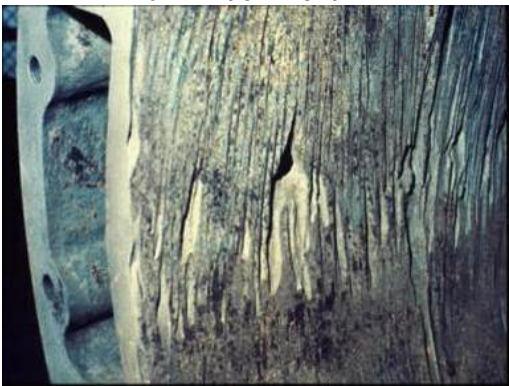
Fig 2 – entrainment erosion

When silts and gravel are carried up in the fluid stream they are said to be entrained. This type of erosion causes greater material loss than impingement alone for the same given fluid velocity.

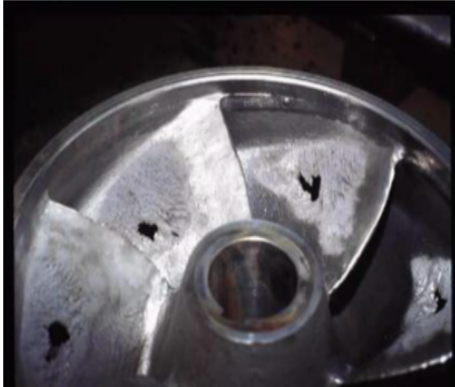
Fig 3 – cavitation (impeller)

Cavitation occurs as a result of a pressure difference in the fluid and can be found on either pump body or impeller, although it is most commonly observed on the impeller, in particular the low pressure surfaces. This picture shows cavitation on impeller blades and on the adjacent surfaces. It is recognized by “peppering” of the surface with many small pits, caused by the implosion of the vapour bubbles onto the substrate.

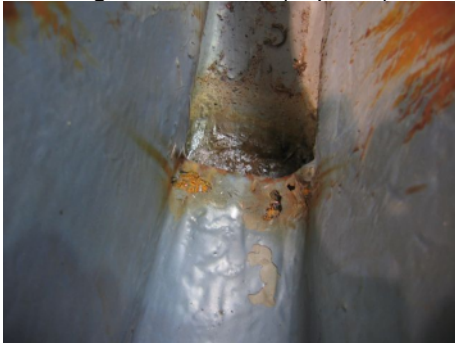
Fig 4 – Cavitation to pump cutwater

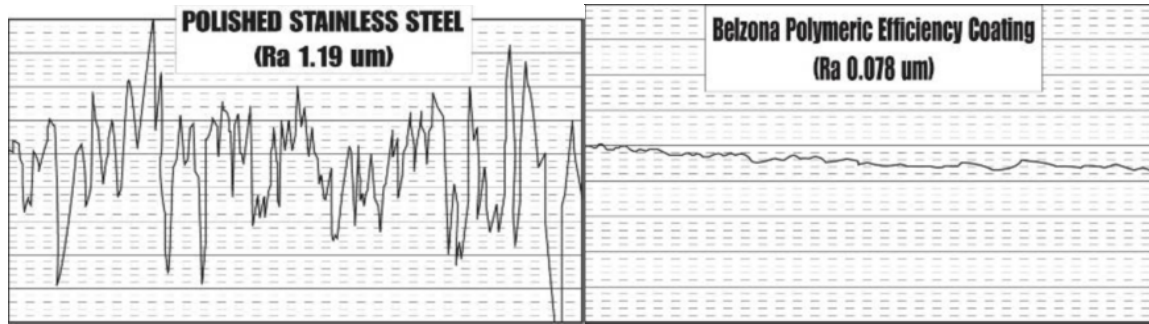
Fig 5: Roughness comparison between polish stainless steel and Belzona®1341 Supermetalglide
 ([5]Talysurf Surface Inspection, Leeds University, 1989)

The smoothness on the surface of this type of coating is more than 15 times greater than polished stainless steel (Fig 5). When applied to fluid flow equipment, this type of coating has been proven to improve hydrodynamic performance by increasing overall efficiency through reducing power consumption, increasing fluid flow rate or pressure.

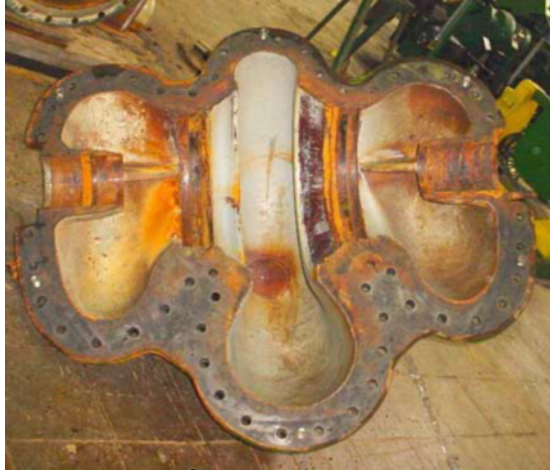
In 1992, this Belgian chemical plant cooling water pump was coated with Belzona®1341 Supermetalgilde. The capacity of this equipment, running 24 hours a day, is 5000 cubic meters of water per hour. During a maintenance shutdown in 2004, the pump was inspected and found to be still in excellent condition, despite the salty water and the years of operation (Staining is from untreated components in the system). As illustrated in this picture, 12 years after the initial application, this pump was still offering added benefit to the longevity of the Belzona®1341 Supermetalgilde application with a 7% increase in efficiency as measured by increased output that has been documented by the end user.

Fig 8: Belzona®1341 Supermetalgilde after 12 years service
