# **Tank Base Sealing**

As a result of adverse weather conditions or condensation, moisture can accumulate at the chime angle or track under the base of the tank. This can lead to corrosion problems, leakage or ultimate tank failure.

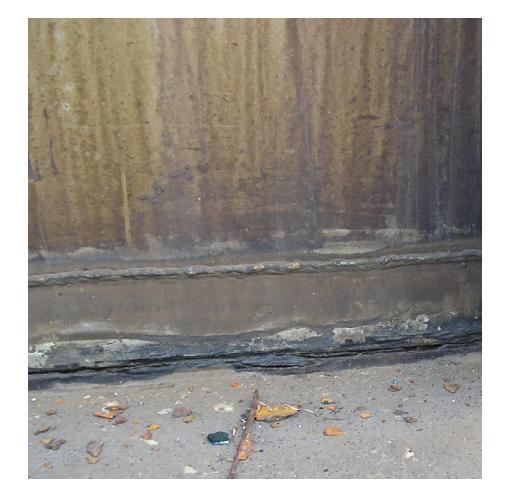
#### Problem

Materials engineers on-site had highlighted that a stress corrosion cracking environment could be created if water was allowed to ingress under the tank floor.

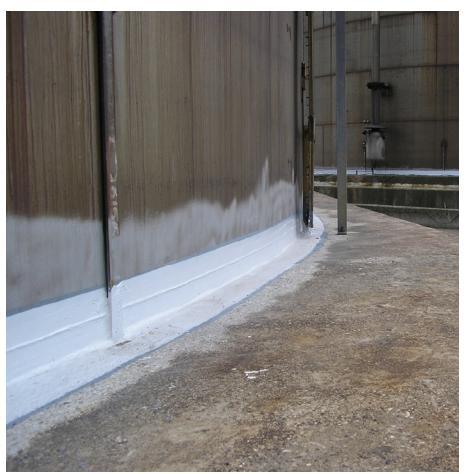
Solution Belzona 3111 (Flexible Membrane) was applied to eight of their carbo

was applied to eight of their carbon steel tanks and three stainless steel tanks.

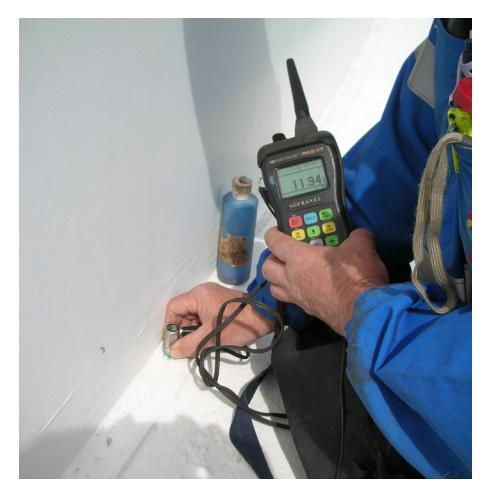
## In-service inspection Annular ring non-destructive

inspection is possible through the membrane without needing to break it.

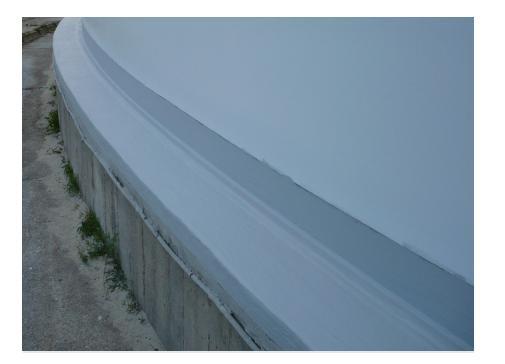
After continuously having to reapply failing tank base sealing systems, this tank refinery installed a Belzona membrane. Following inspection after 13 years in service, the Belzona system was found to be in excellent condition.
