# Belzona 1523

## Spray Applied Coating for the Protection of Process Equipment Operating at Elevated Temperatures

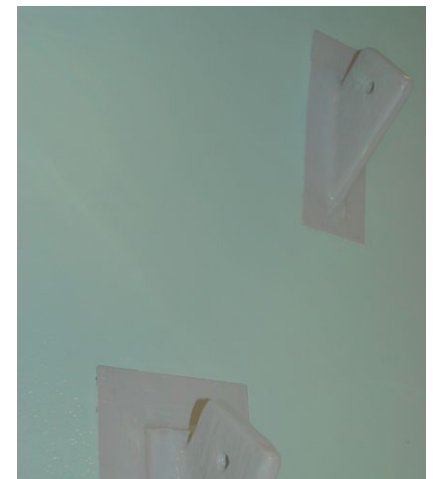
The very light colours of Belzona 1523 allow easy visual inspection in vessels. This coating can also be High Voltage spark tested for holidays.
