Belzona Launches New Pourable Chocking Compound

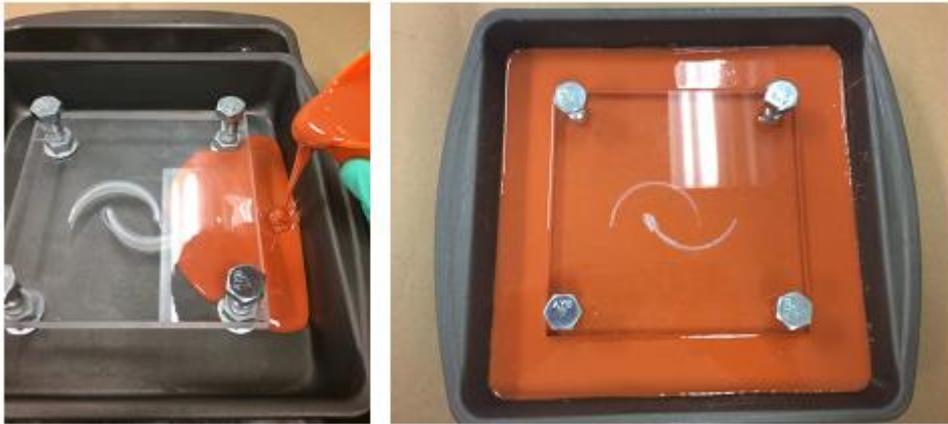
Belzona 7111 application demonstration

Belzona 7111 is reported to be ideal for pouring foundations for heavy ship propulsion systems and other heavy equipment where alignment and anchorage are essential. Since machining of foundations is not required, the cost and time for machinery installation can be reduced significantly.

The system is 100% solids, therefore it will not shrink during cure and possesses self-leveling properties, facilitating quick and simple application. Excellent load bearing capability is demonstrated by a comparably high compressive strength. Tested in accordance with ASTM D695, compressive yield strength measures at 14930 psi (102.9 MPa) and compressive modulus at 5.75×10^5 psi (3964 MPa). Available in grey or orange, Belzona 7111 features high creep, corrosion and vibration resistance, ensuring lasting performance under various service conditions.
