Belzona Seals Exposed Parking Deck Seams

Over 15000 linear feet of expansion joint seams needed to be sealed

Customer was looking for a long lasting solution for sealing seams on an exposed concrete parking deck

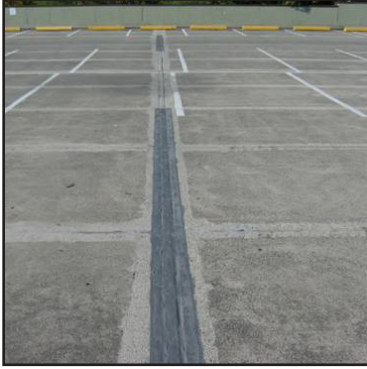
Initial test area after more than 2 years service

Test strips were installed at the site in 2000. Both 3111 and 3121 were submitted. Both products performed well showing no deterioration after 2 years. Belzona 3121 was chosen for its relative ease of application. Application has been spread over 3 years with a total of about 15,000 linear feet of seams completed.

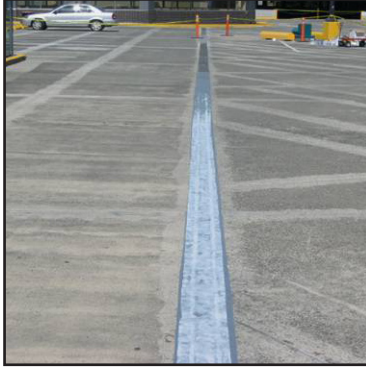
*Application in progress -
1st coat with Reinforcement Sheet
in place*

Application was carried out in accordance with a modified version of Belzona Know-How System Leaflet RPA-1.

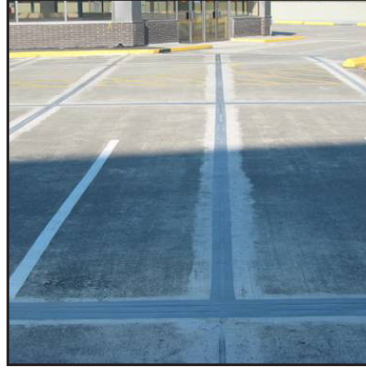
*Application of 2nd coat in
progress*

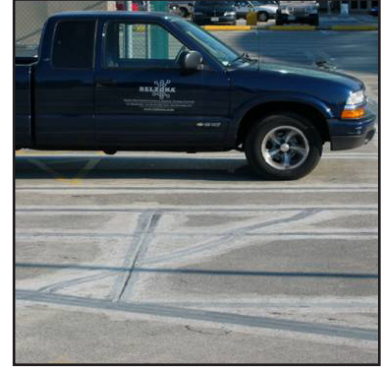
Completed section of deck
