## Belzona Used on Ferry Water Jet

Ferry water jet propulsion units.

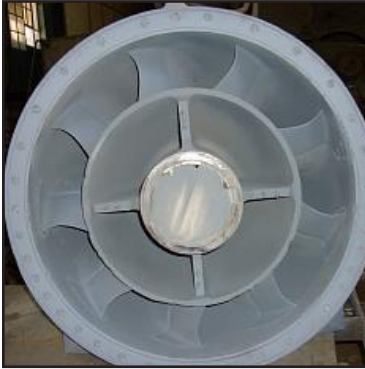
*Unit before coating*

Units had significant erosion-corrosion.

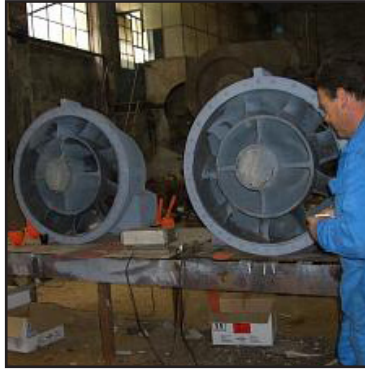
*Application of Belzona*

Application was carried out in accordance with Belzona Know-How System Leaflets FBC-1 & FBC-2.
