Belzona Demonstrates Faultless Concrete Repair Since 2002

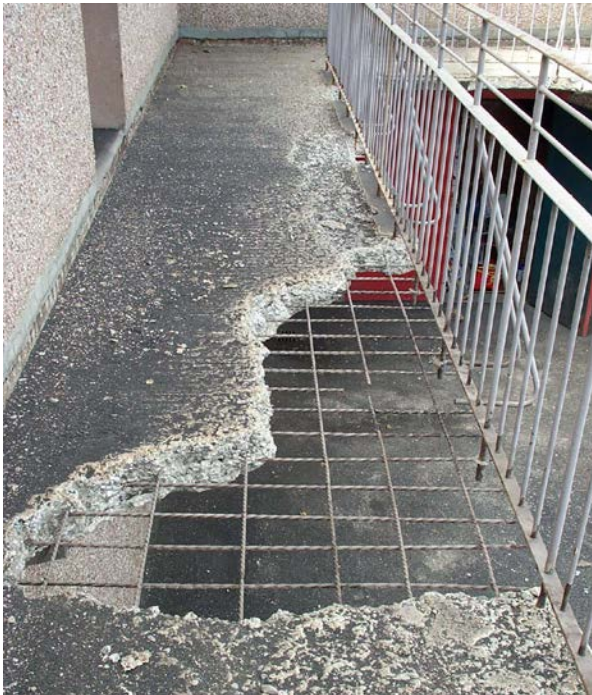
The concrete had been chemically attacked by grit and salt leading to sever spalling. When the asphalt was removed, major issues were revealed causing great concern for the schools maintenance team. Belzona specified their 4131 (Magma Screed) which was approved by the local council engineers due to the products mechanical and physical properties. The application was undertaken during the summer holidays of 2002 by Belzona Authorised contractors, Murray and Burrell.

Damaged Concrete Walk Way 2002

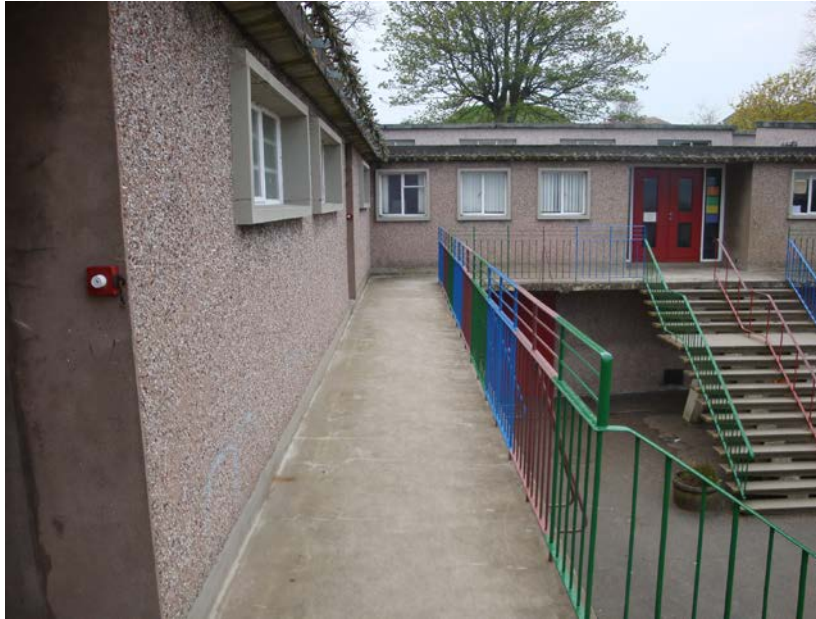
Murray and Burrell have recently returned to the school in May 2011 following 9 years in service. After inspection of the application, there

has been no sign of further concrete damage and the walkway has maintained its structure keeping the pupils of the primary school safe. It is envisaged that the application will comfortably achieve the required application life.

Application 9 years on
