Coating for Protection Against Corrosion, Abrasion and Chemical Attack

5111

Belzona 5111 (Ceramic Cladding) is a two-component coating designed for the long-term protection of metallic surfaces and masonry against physical, chemical and bacterial attack.

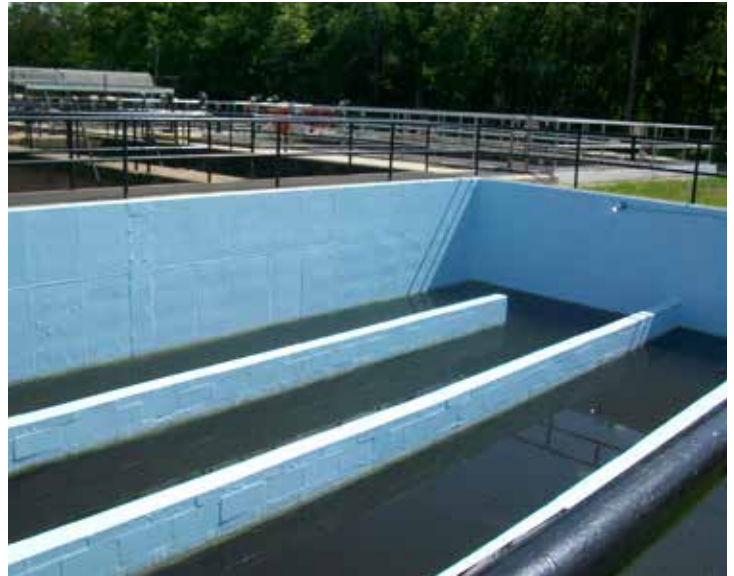
Belzona 5111 used for wall protection of a chlorine tank

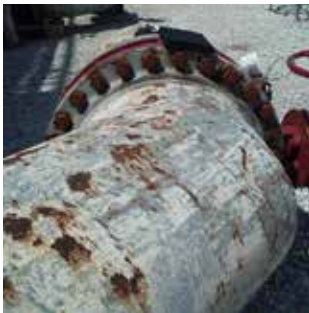
Pipe before

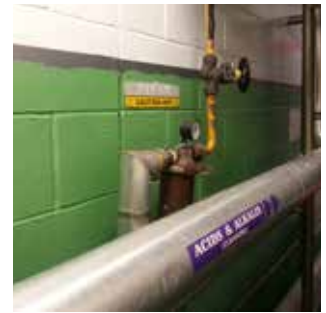
Wall after
