## Superior Composite Technology Developed for Pipe and Tank Repair and Protection

Already with a 100% application success rate, Belzona's high-tech pipe wrap repair system has undergone a major reformulation and enhancement.

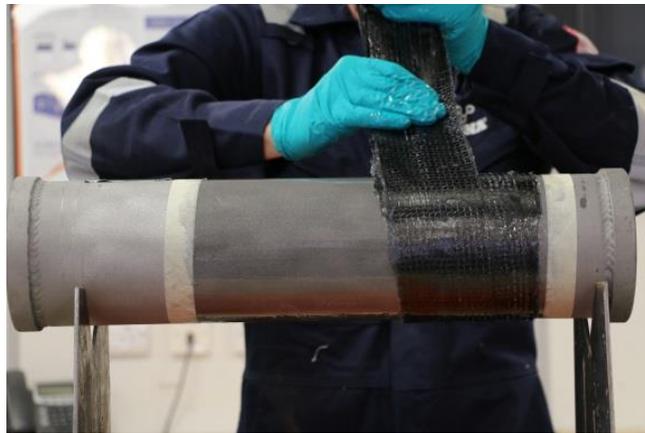
[Application of SuperWrap II on pipe spool]

- 1) First apply the selected resin grade product, Belzona 1981 or Belzona 1982, to the blasted substrate.
- 2) On to this, the Belzona 9381 reinforcement sheet, wetted with the selected low density resin (Belzona 1981 or Belzona 1982), is spiral wound onto the repair area, adding strength.

- 3) When all wraps have been applied to specification, further resin grade product is then applied on top of the reinforcement layers if required.
- 4) The repair is then consolidated by tightly wrapping the Belzona 9382 Release Film over the repair area, ensuring a high quality laminate, with no air entrapment or voids.

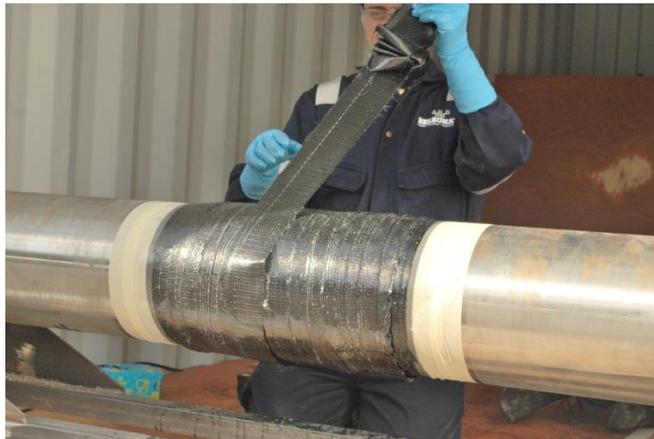
[Pressurised to target pressure of 39.2MPa, pressure taken 5% over, no failure seen, but substrate began to yield]

During the Annex C test (ISO 24817) and Appendix III (ASME PCC-2 Article 4.1), a test designed to rebuild the damaged section of pipe back to its original yield strength, the repair withstood the calculated yield pressure of the substrate, whilst the original steel profile showed signs of yielding.

The test involved machining a 125mm x 62.5mm rectangular defect into a 250mm diameter pipe (2000mm in length). The original wall thickness of the pipe was 10mm, and in the defect area this was reduced to 2mm. The yield pressure of the undamaged spool was calculated to be 39.2MPa, a repair was engineered to restore the pipe to this original pressure.

The repair was applied to specification and the pipe was then pressurised up to 39.2MPa, without failure, demonstrating that the Belzona SuperWrap II had performed as designed. Pressure was then increased to determine where a yielding would occur – in the repair or in the original pipe. At around 42MPa, the pipe clearly yielded, outside of the repair area. This demonstrated that not only had the wrap returned the pipe to its original strength, it had also made the defect area stronger than the original pipe section.

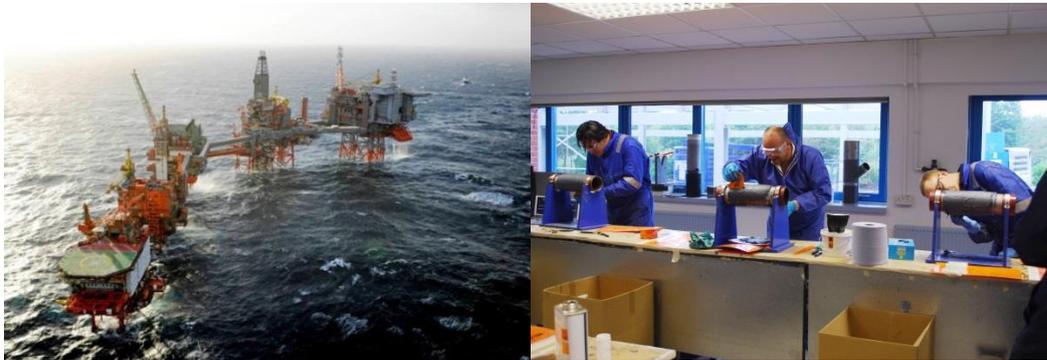
[Belzona SuperWrap II can be used in a variety of application areas]  
[Theoretical and practical training available at Belzona head offices]
