Belzona® 3111 (Flexible Membrane) Protection in a Power Plant

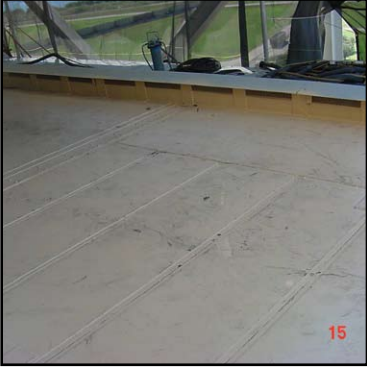
Roof over cascade area prior to the application (note seams).

Water getting through collapsible roof seams wets coal and reduces fuel efficiency. Work area extremely dirty due to coal fines from belts.

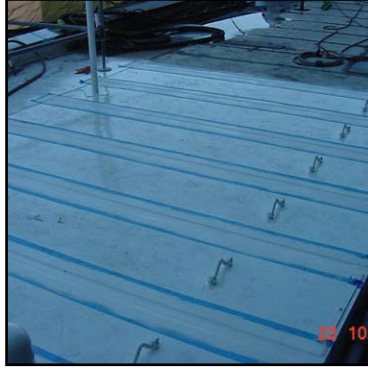
Seams areas taped off.

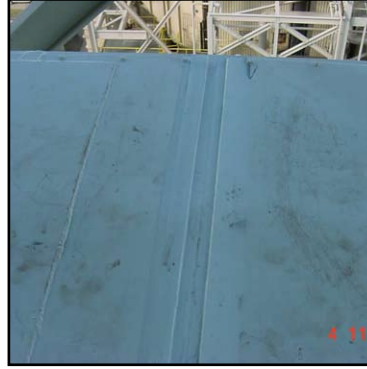
First coat of Belzona® applied.

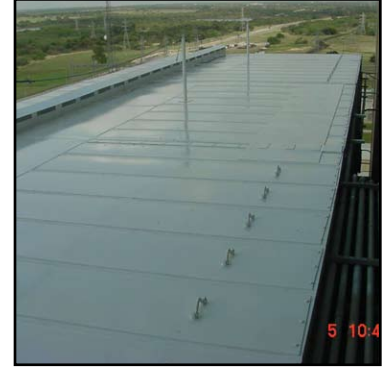
Completed roof.
(Roof was painted following the application of the Belzona.)
