Belzona Protection to Butane Tank Base

STATISTICS

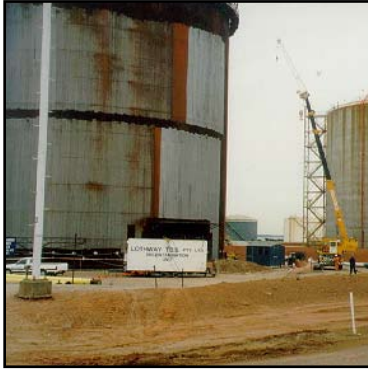
General view of the tank

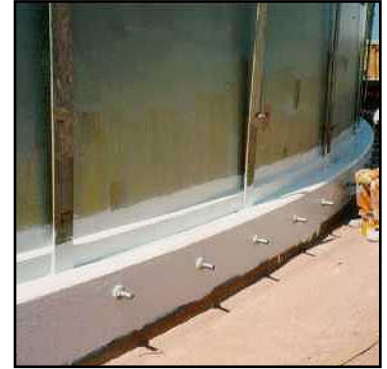
Application being completed

Belzona application creates a flexible, waterproof but microporous seal at junction of tank and base to provide long-term corrosion protection.
