Belzona Secures "A" Brackets to Yacht Hull

Propeller shaft "A" bracket supports.

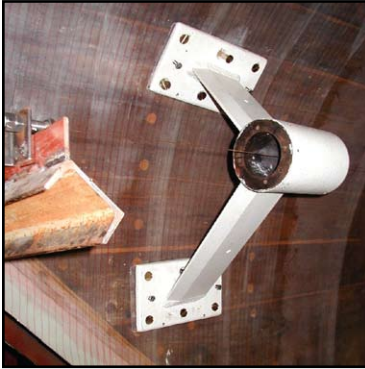
Bracket positioned using aligning wire and jacking bolts.

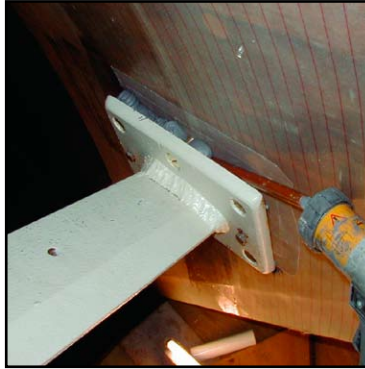
Belzona[®] 1121 being injected between hull and bracket.

The Belzona provides a high-strength irregular shim under "A" brackets ensuring no stress points on the hull. Non-slump properties of the Belzona important as gaps to be filled ranged from 3 to 25mm (1/8" to 1")

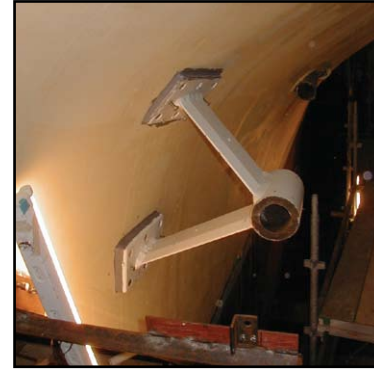
Completed application.
