## Belzona Air Handling Fan & Shroud

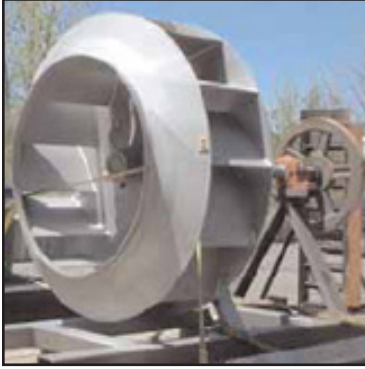
*Fan blasted to 3-4 mil profile, white metal finish*

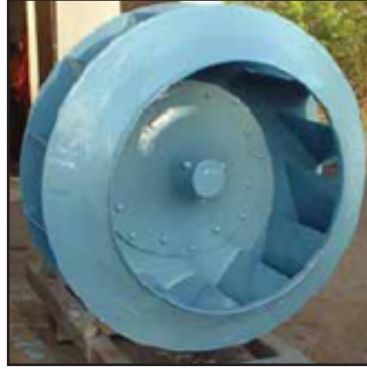
*Second coat of Belzona® 1341 completed on fan*

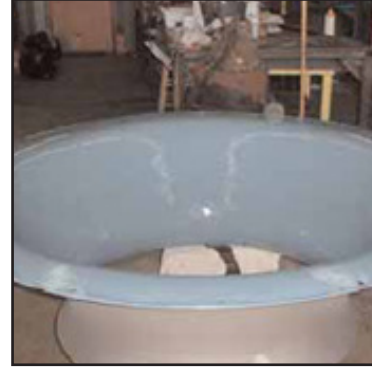
*Shroud coat completed*
