Belzona Seals Exposed Parking Deck Seams

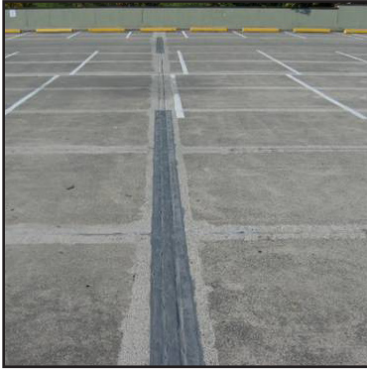
Initial test area after more than 2 years service

Test strips were installed at the site in 2000. Both 3111 and 3121 were submitted. Both products performed well showing no deterioration after 2 years. Belzona 3121 was chosen for its relative ease of application. Application has been spread over 3 years with a total of about 15,000 linear feet of seams completed.

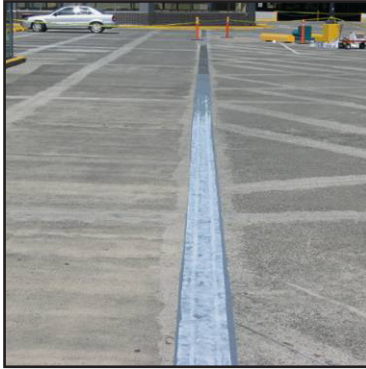
Application in progress - 1st coat with Reinforcement Sheet in place

Application was carried out in accordance with a modified version of Belzona Know-How System Leaflet RPA-1.

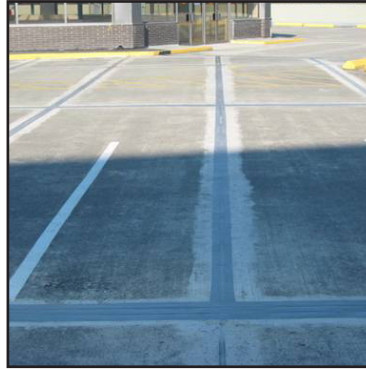
Application of 2nd coat in progress

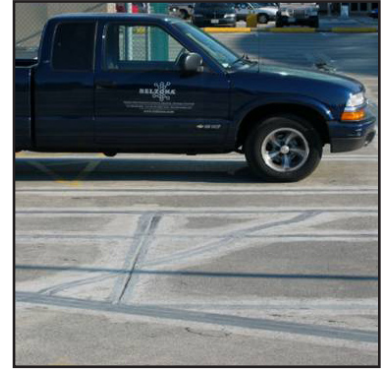
Completed section of deck
